A&T HOME INSPECTIONS

Home Inspection Report

123 Your Street Dallas, TX 75201

16-0404

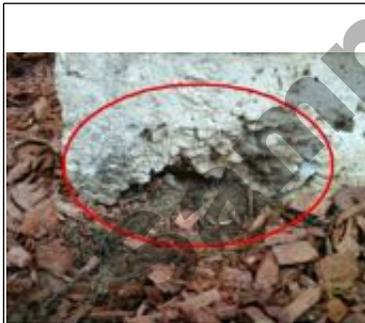
Comments: Surface deterioration (known as spalling) was observed on the exterior of the exposed foundation. This condition is common in many homes and does not usually represent a structural concern. In an effort to prevent long term deterioration, it would be wise to consider parging deteriorated areas. Lot drainage improvements, as outlined in the "Exterior" section of this report are also recommended.

Spalling on the west side of house.

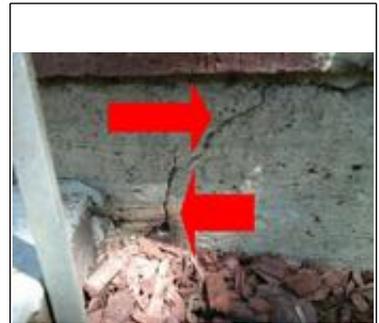
Diagonal crack on the west side of house.

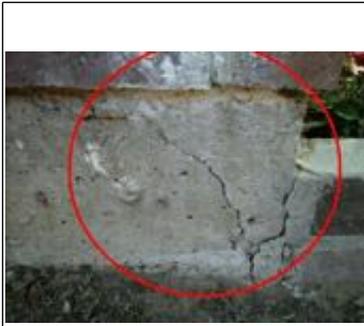
Corner crack on the northwest corner of house.

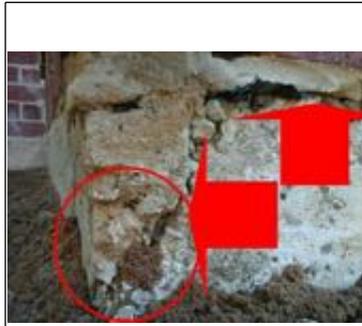
Spalling and cracking on the north side of house.

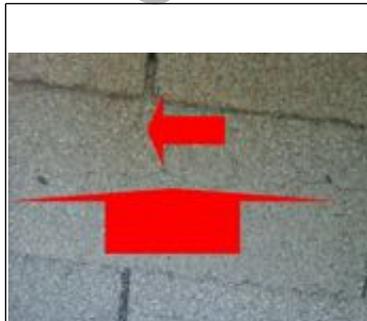
Cracked shingle

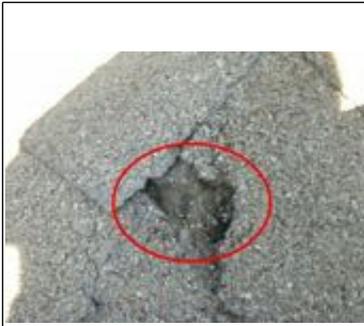
Torn/damaged shingle.

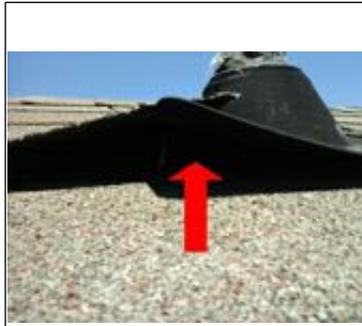
Nail heads are exposed at the flashing. They should be sealed to reduce risk of leaks.

Nail pop in the flashing.

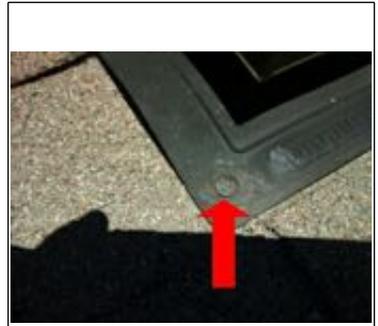
Exposed nail in the flashing. Should be sealed to prevent leaks.

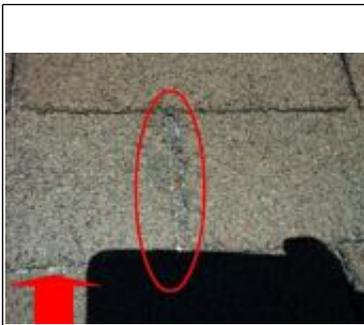
Shingles are frayed on the edges.

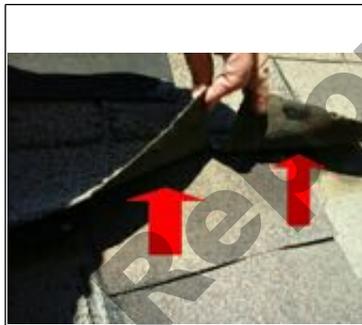
Loose shingles

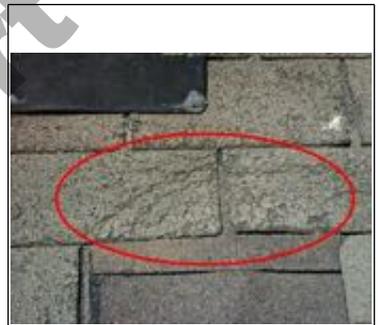
Same 2 loose shingles that are damaged on top.

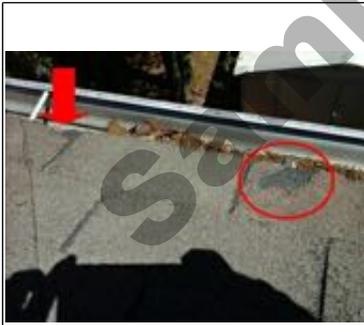
More damaged shingles.

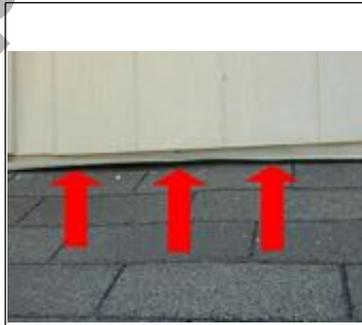
Nail pops in the flashing on the front part of roof.

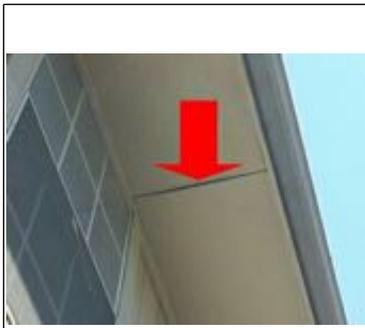
Soffit is split and bowing on the south side of house.

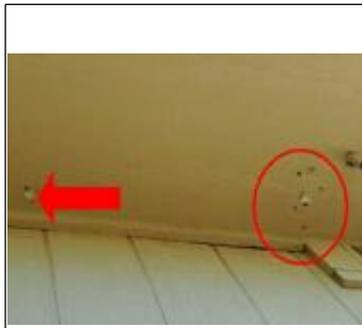
Some soffit damage on the south side of house.

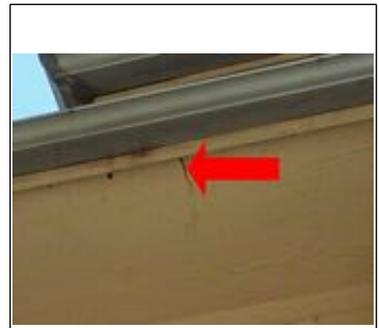
Soffit is cracked on the west side of house.

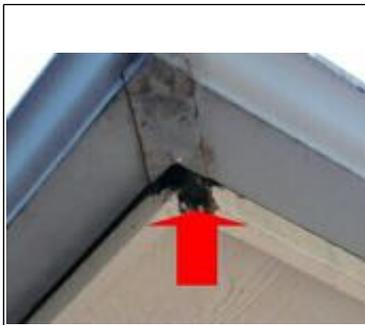
Wood rot at corner of fascia board on the west side of house.

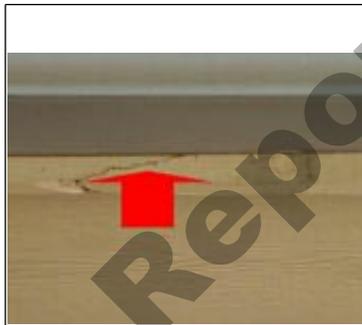
Cracked fascia board on the west side of house.

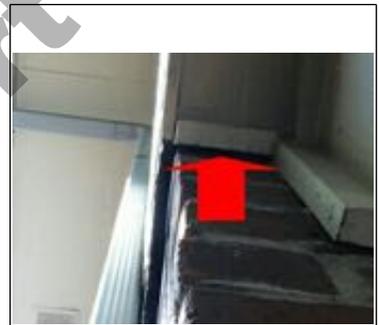
Trim is pushed backward from movement on the southwest corner of house.

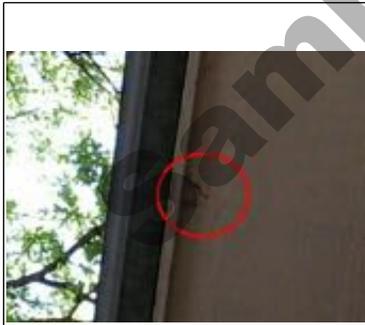
Soffit damage on the south side of house.

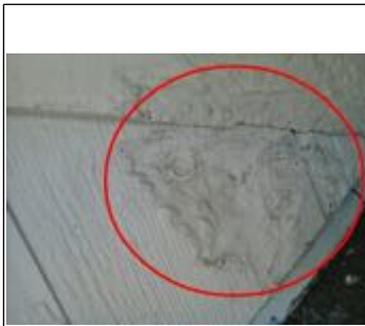
Wood had rotted out and been filled with puddy. Located under top roof to the next level of roofing.

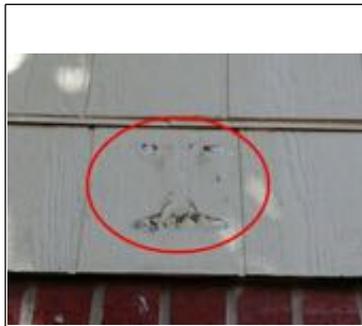
Damage to the wall on the south side of house.

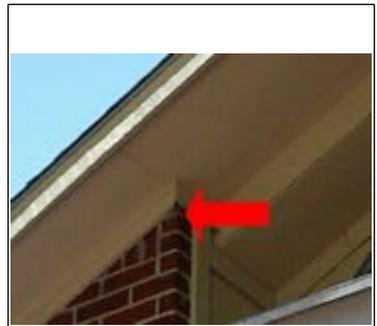
Missing brick and/or mortar in the corner on the west side of house.

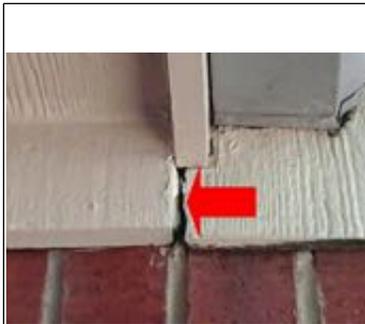
Split at connection. Should be repaired.

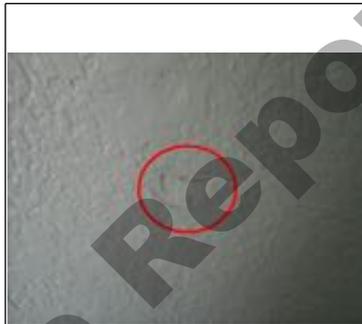
Denting and damage to wall from the front door knob.

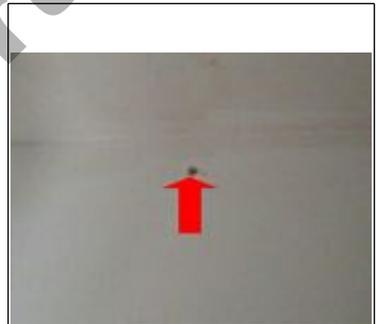
A nail pop in the garage.

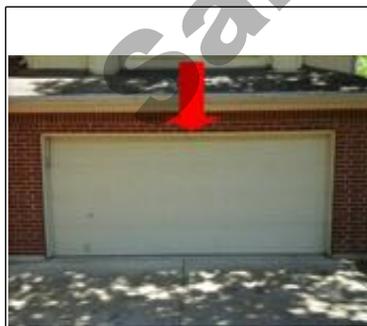
Garage door frame is bowing in the middle.

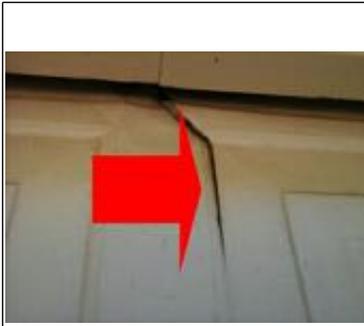
Comments: The overhead garage door is damaged and needs repair.

Garage door cracked right in the center of the door.

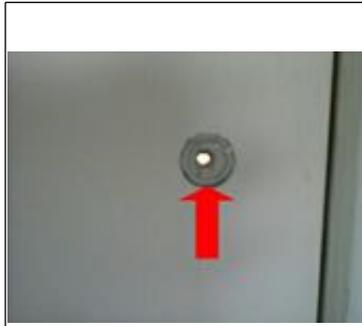
A hole in the front door.

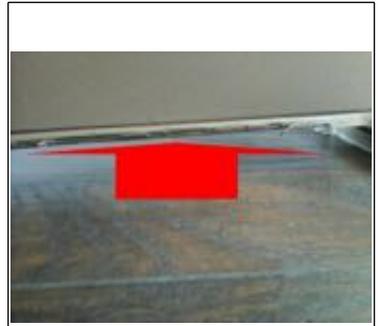
Weather stripping damaged at bottom of the back door.

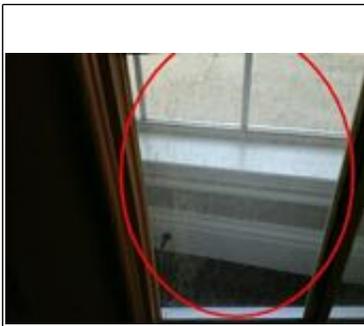
Back door glass is scratched up.

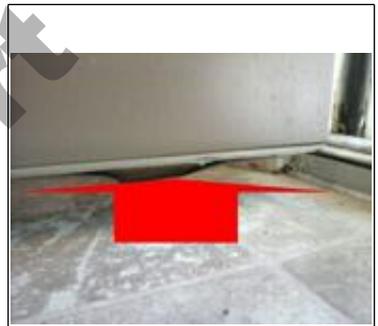
Weather stripping is damaged on other exterior door from garage.

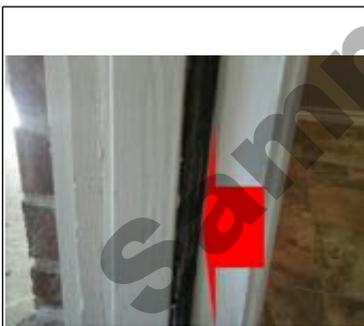
Weather stripping damaged around the other exterior door from garage.

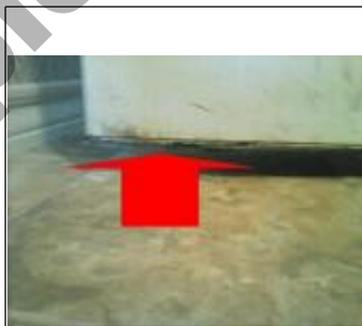
Damaged weather stripping on one of the service doors.

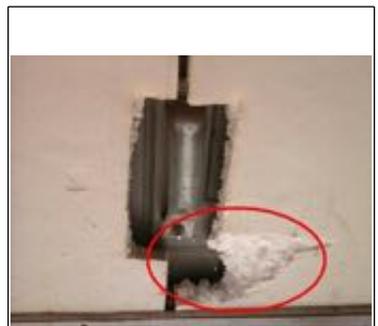
Foam cut out around the door handle.

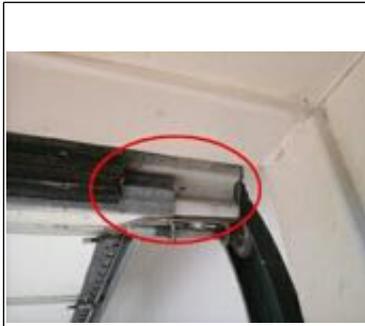
Weather stripping is missing in the corner.

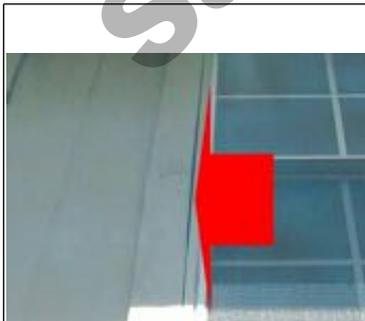
Board is bowing and separating from frame on the south side of house.

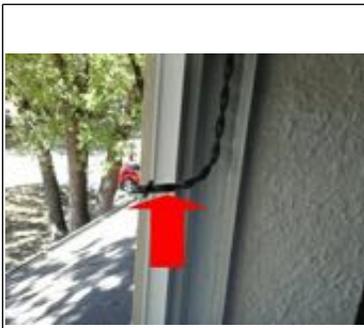
Window in front left bedroom does not stay up at all. The sash is bent and damaged.

The sash is bent and damaged.

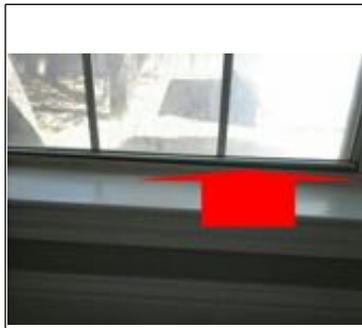
Window does not sit flush in the dining room due to a nail sticking up underneath.

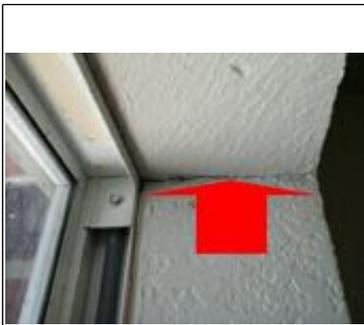
Crack in corner of window in the extra room from garage.

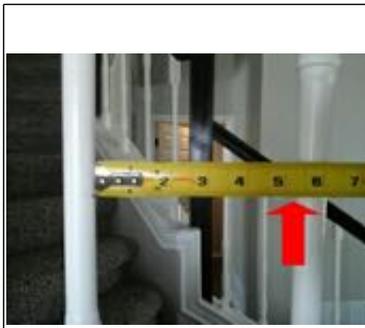
Stairs: The baluster opening is over 4" and is a safety hazard.

Comments: The stairwell balusters and/or spindles are installed too far apart. Under current building standards the required guardrails on open sides of stairways, raised floor areas, balconies and porches should have intermediate rails or ornamental closures which do not allow passage of an object more than 4-inches .

Balusters are too far apart. This is a safety hazard.

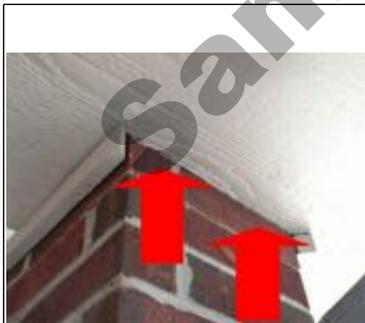
Missing trim on the front porch covering.

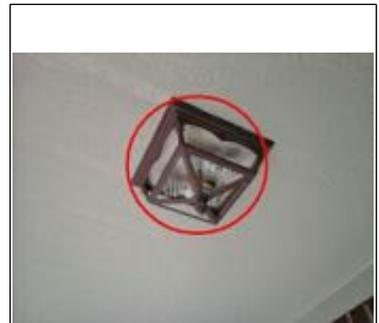
Missing light cover on back patio covering.

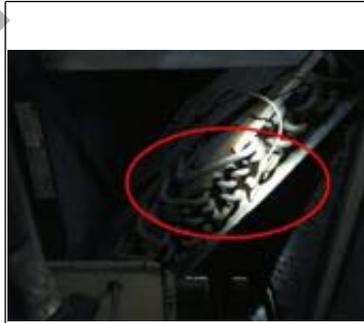
Some residue from previous water in the condensation tray.

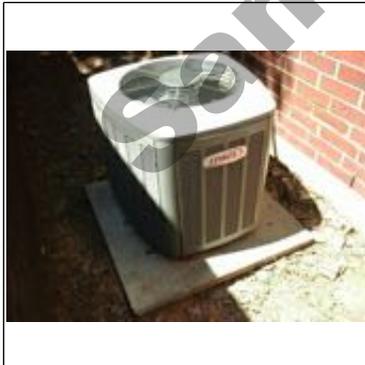
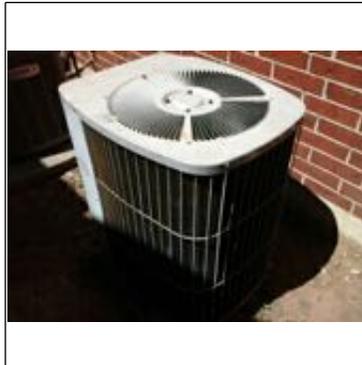
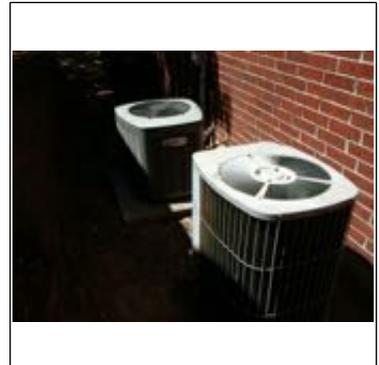
Comments: Both outdoor unit of the air conditioning systems are out of level. This should be improved. I can rock them both.

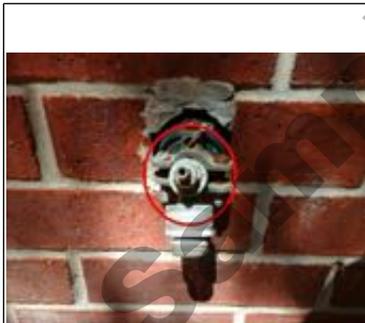
Hose Bibs: Yes the exterior has hose bib(s) and the one around back is missing it's service valve.

Supply valve is missing.

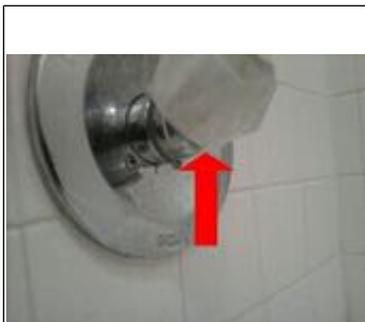
Sinks/Tubs/showers: Faucet leaks in upstairs bathroom.

Faucet leaks in upstairs bathroom.

The faucet on the upstairs tub is leaking and should be repaired.

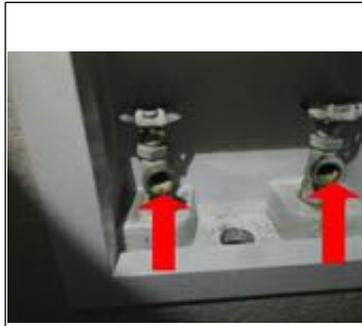
Water service lines for washing machine are leaking.

Both service lines are leaking for the washing machine.

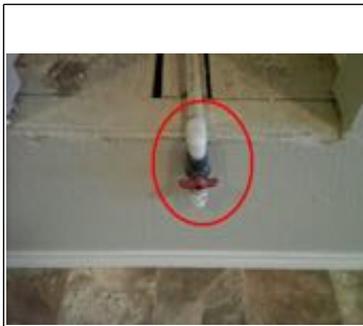
Condition and Issues: Not supposed to drain inside from drain pan. The drain needs to run to the exterior of the house.

Drain pipe from the drain pan is set to drain inside. This is incorrect and should be repaired to go outside.

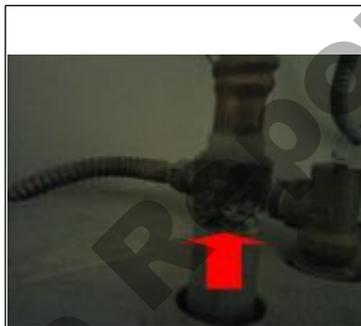
Comments: The supply piping shows evidence of corrosion where it meets the water heater. This is a common condition and should be repaired.

Corrosion at supply connection.
