A&T HOME INSPECTIONS

Home Inspection Report

123 Your Street Dallas, TX 75201

16-0404

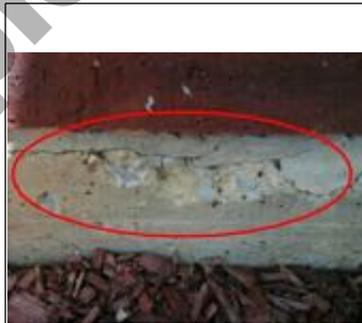
Comments: Surface deterioration (known as spalling) was observed on the exterior of the exposed foundation. This condition is common in many homes and does not usually represent a structural concern. In an effort to prevent long term deterioration, it would be wise to consider parging deteriorated areas. Lot drainage improvements, as outlined in the "Exterior" section of this report are also recommended.

More spalling on the west side of house.

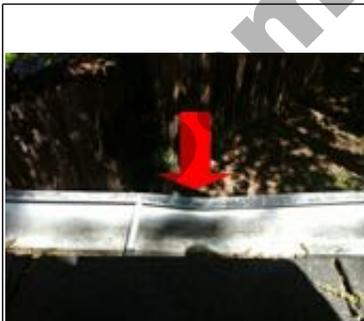
Dented gutter.

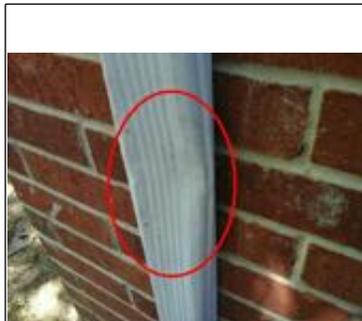
Dented downspout.

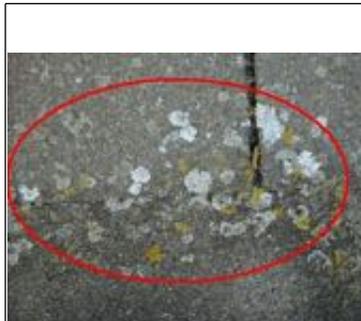
Roof Conditions: The roofing material has signs of moss buildup on it.
The roofing material has exposed nails. (Nail pops)
The roofing material is showing signs of cracking.
I would recommend a professional roofer to come evaluate further.

Mossy area on roof.

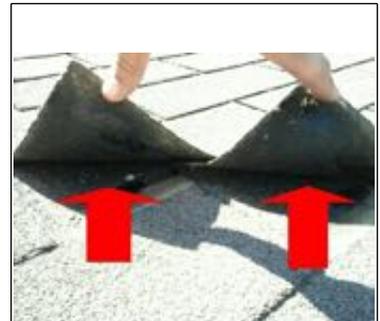
Wind blown shingles.

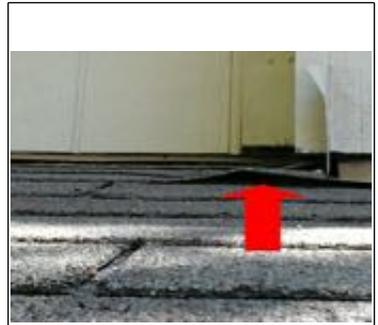
Cupping along the edge of flashing.

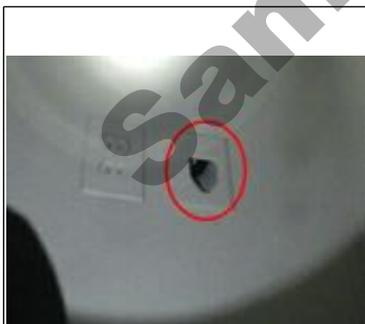
Cover plate busted through for a hole in the closet of the sitting room off of the master bedroom.

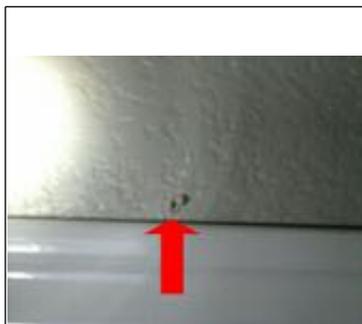
A little hole above the closet door in the sitting room.

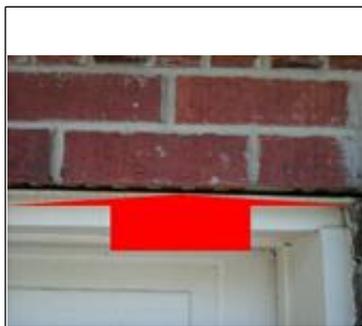
Separation at the lintel and the brick above garage door.

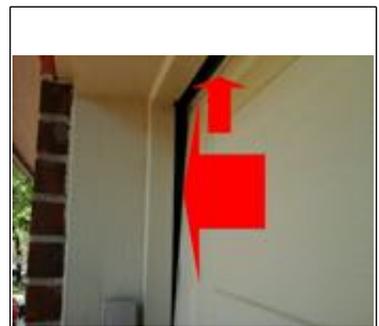
Garage door has large gap on left side. Should be flush.

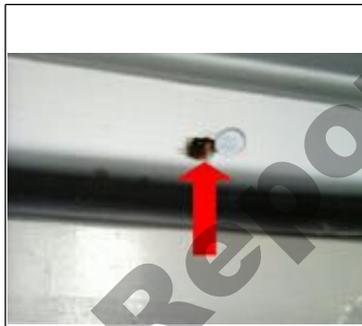
Back door frame has a hole in it.

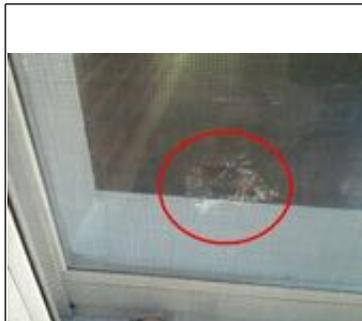
Hole in the screen on the east side of house.

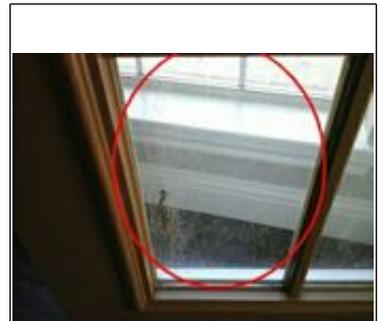
Back door glass is scratched up.

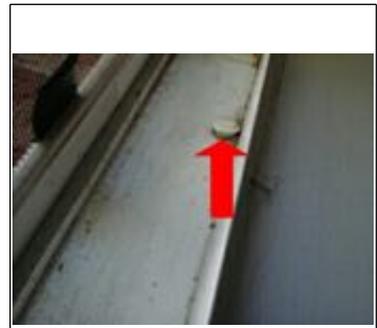
Nail sticking up under window pane in dining room.

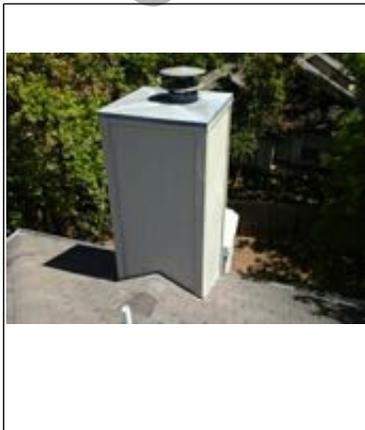
Flashing has separated from movement around the chimney.

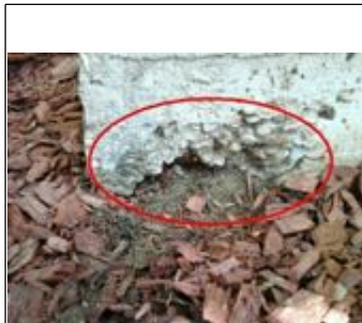
Spalling on the front porch.

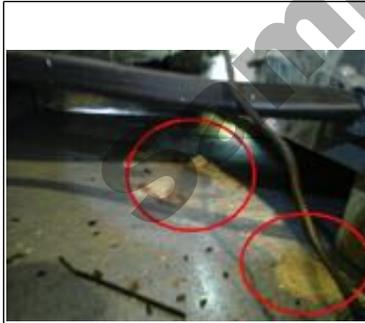
Some residue from previous water in the condensation tray.

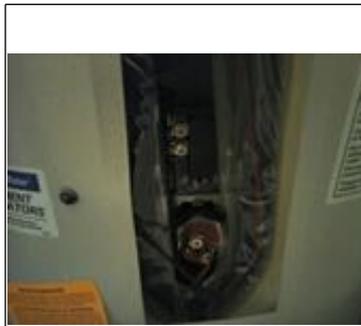
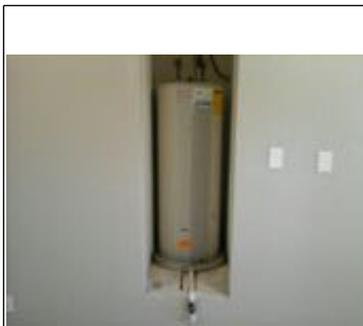
Condition and Issues: Not supposed to drain inside from drain pan. The drain needs to run to the exterior of the house.

Drain pipe from the drain pan is set to drain inside. This is incorrect and should be repaired to go outside.

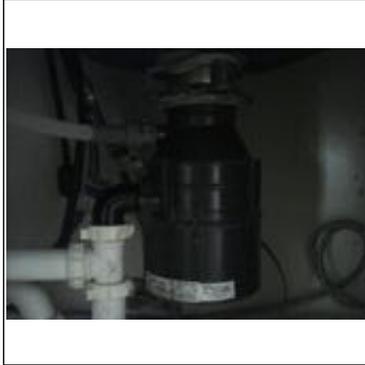
Comments: The food waste disposer is excessively noisy. Repairs may be necessary.
